### **An assessment based on bow-ties**

Chemical Engineering Transactions

# Mechanical Integrity of Process Installations: an Assessment Based on Bow-Ties

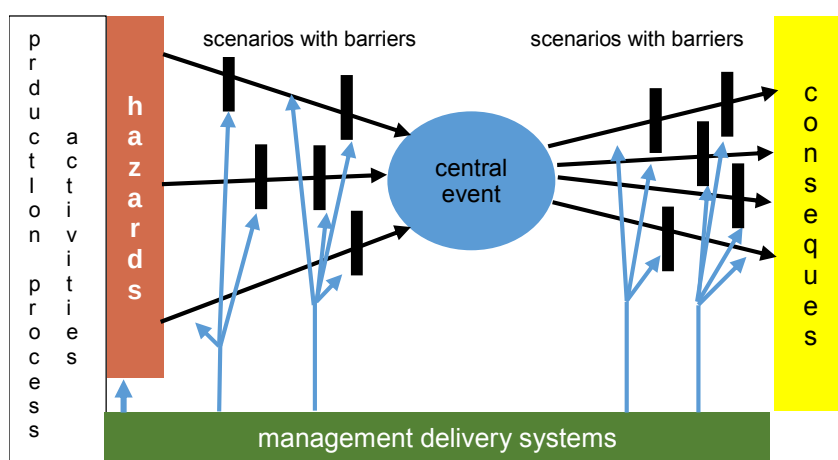
Figure 1: Bow-tie metaphor (Visser, 1998)

Bow-ties are appropriate and user-friendly for the mapping of scenarios (Chevreau et al., 2006, de Ruijter and Guldenmund, 2016). It is a metaphor for an accident process and shows the initiating event of a scenario, the consequences and the barriers that can stop the scenario from happening (Swuste et al., 2016). The simple, sequential design of bow-ties is strongly reminiscent of the 'Swiss cheese model' by Reason (1990) with the cheese slices as barriers. Figure 1 shows a bow-tie of which the explanation is included in a paper of Swuste et al., entitled "Process safety indicators, how solid is the concept?" and also published in the LP 2019 conference proceedings.

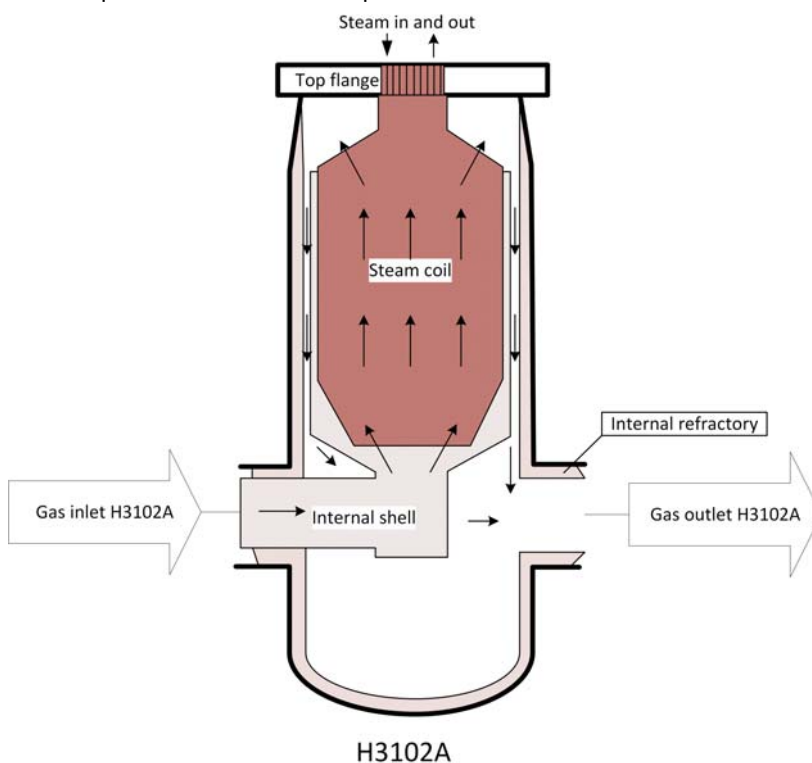
In the steam superheater, high pressure steam of 125 bar is superheated by means of hot process gas, which consists of about 35% hydrogen. The process gas decreases from 600 °C to 475 °C. Figure 2 shows the flow of the process gas which is led upwards via the internal heat exchanger and returns along the wall after which it exits on the right-hand side. The process gas that leaves the internal heat exchanger at the top passes the internal brickwork (refractory) that protects the outer wall against a too high temperature. Two time-related mechanical failure mechanisms have been identified, which can cause the steam superheater to fail catastrophically, i.e. a sudden, unstoppable, total loss of the containment. In the case of damaged refractory,

Figure 2: Steam superheater

the outer wall can be exposed to excessive heat for a prolonged period of time which may lead to creep (slow plastic deformation under the influence of stress and temperature) and Nelson hydrogen attack (diffusion of H-atoms into the metal causing methane to form stresses cracking).

In case of refractory defects hot spots can occur on the outside of the wall. Although they can be observed visually during an operator round, they can easily be overlooked. The quality of the current detection and monitoring of the failure mechanism (D) is classified as poor. The internal refractory is inspected every four years during a turn-around. As indicated above, only minor defects have been found. This barrier is therefore qualified as good. In the current situation, the criticality C ( $P \times D \times B$ ) is equal to 24 ( $3 \times 4 \times 2$ ). The scenario must be provided with extra or improved barriers.

It appears that it is possible to provide this heater on the outside with indicator paint, which discolors on the hot spot due to the higher surface temperature where the internal refractory is no longer intact. Indicator paint reduces the chance that hot spots are overlooked. In addition, the outer wall can be provided with a number of temperature measurements that alarm at a high temperature. In case of a discolored indicator paint and / or one or more temperature alarms, the wall can be examined with an IR camera in order to determine whether a 'fitness for service' (FFS) analysis should be carried out. This should then indicate whether an inspection is necessary. The inspection should reveal the need for replacement or repair. If this procedure receives management attention, the quality of the detection and monitoring of the failure mechanism (D) can be regarded as good in accordance with equivalent procedures within the company. The procedure should not only be included in the safety management system but also contain some kind of management involvement when in use. In addition, the temperature alarms should not only raise an alarm in the control room but also be passed on to those who are responsible for the integrity and asset management. The criticality in the improved situation is 12 ( $C = P \times D \times B = 3 \times 2 \times 2$ ) and thus the scenario is sufficiently safeguarded. No additional barriers are required if the detection and monitoring are implemented as proposed above.

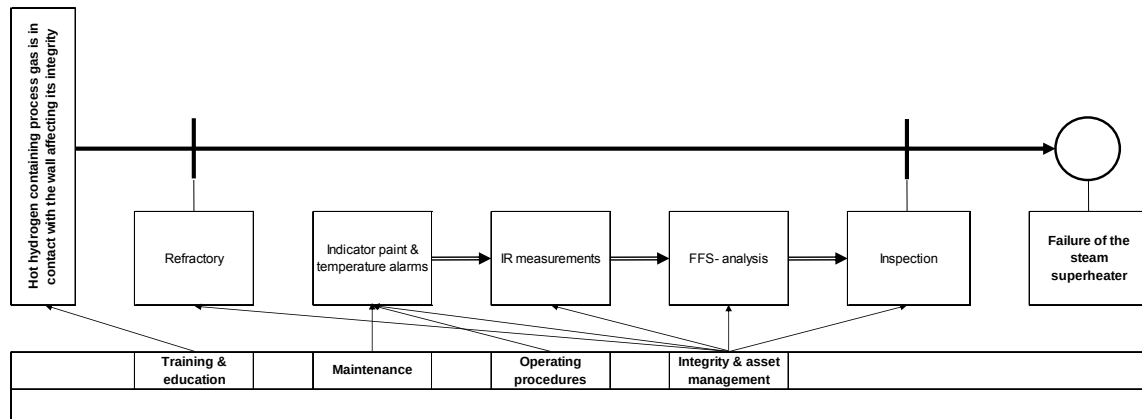
Figure 3 shows the bow-tie of the scenario with the newly implemented detection and monitoring. Together with the internal refractory, this forms a 1-out-of-2 system, that is to say that the scenario is provided with two barriers connected in series. The existing internal refractory is a technical barrier, whereas the proposed detection and monitoring of the failure mechanism is a non-technical, procedural barrier. The latter consists of a detection via the indicator paint, temperature alarms and IR measurement after which a procedure with management attention should ensure monitoring of the failure mechanism in the form of an FFS analysis and inspection. The temperature alarms can be seen as an 'early warning' regarding the failure mechanisms creep and Nelson hydrogen attack.

The figure below also shows which different departments or 'management delivery systems' support and maintain the various barrier components. The influence of the organizational factors on the barriers and how this influence can be monitored is beyond the scope of this research.

Figure 3: Bow-tie with regard to creep and Nelson hydrogen attack of the steam superheater
