Vollaers, V., Nieuwenhuis, E., van de Ven, F., & Langeveld, J. (2021). Root causes of failures in sustainable urban drainage systems (SUDS): an exploratory study in 11 municipalities in the Netherlands. *Blue-Green Systems*, 3(1), 31-48. <https://doi.org/10.2166/bgs.2021.002>

## Root causes of failures in sustainable urban drainage systems (SUDS): an exploratory study in 11 municipalities in the Netherlands

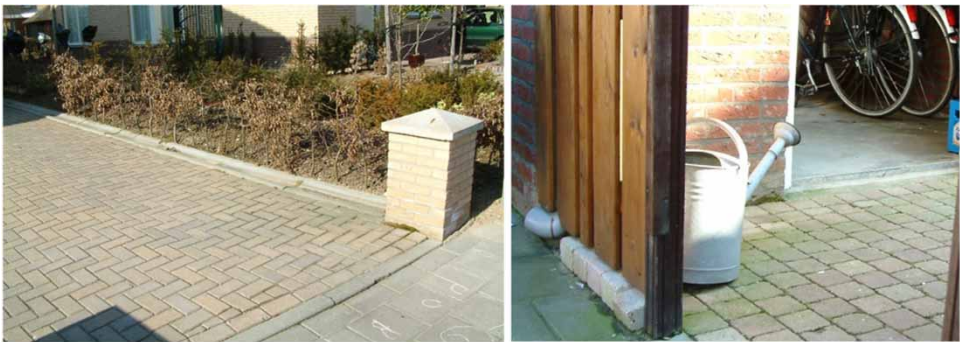
**Figure 1** | Two cases (#13 and #15) of technical failures in SUDS with a failing function of conveyance. Left: an obstacle interferes with the transport of water by an open gutter. Right: due to insufficient slope of the garden, the storm water flows into the shed.

- *Conveyance*: The most common technical failure identified for conveyance systems was *Interference with obstacle* (7 out of 25 cases) (see Figure 1 for an example). This technical failure was previously mentioned by Boogaard *et al.* (2006). The second most common failure is *Insufficient slope* (4 out of 25 cases), which is also in line with previous studies (Boogaard *et al.* 2006; Pötz 2016).
