# Experiences on the use of polymer coated steel net for the protection of dykes against the intrusion of beavers

P. Di Pietro

*Officine Maccaferri S.p.A.*

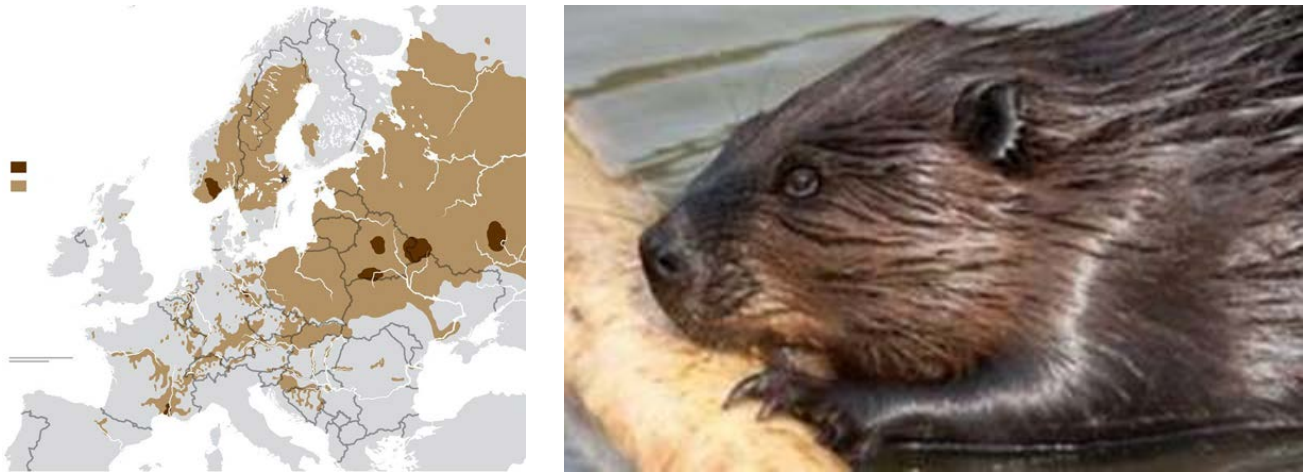
Figure 1. Presence of beavers (brown & dark brown) Fig.2 Beaver population expected to grow to 7000 in 2032.

According to a study published in 2011 [1, 2] by the Bavarian State Office in charge of environmental protection, authors have shown that the beaver population across Germany was estimated at around 25,000 units, with an increasing trend. An estimate across Europe in the same year was of approximately 800,000 beavers (Figs. 1 and 2).

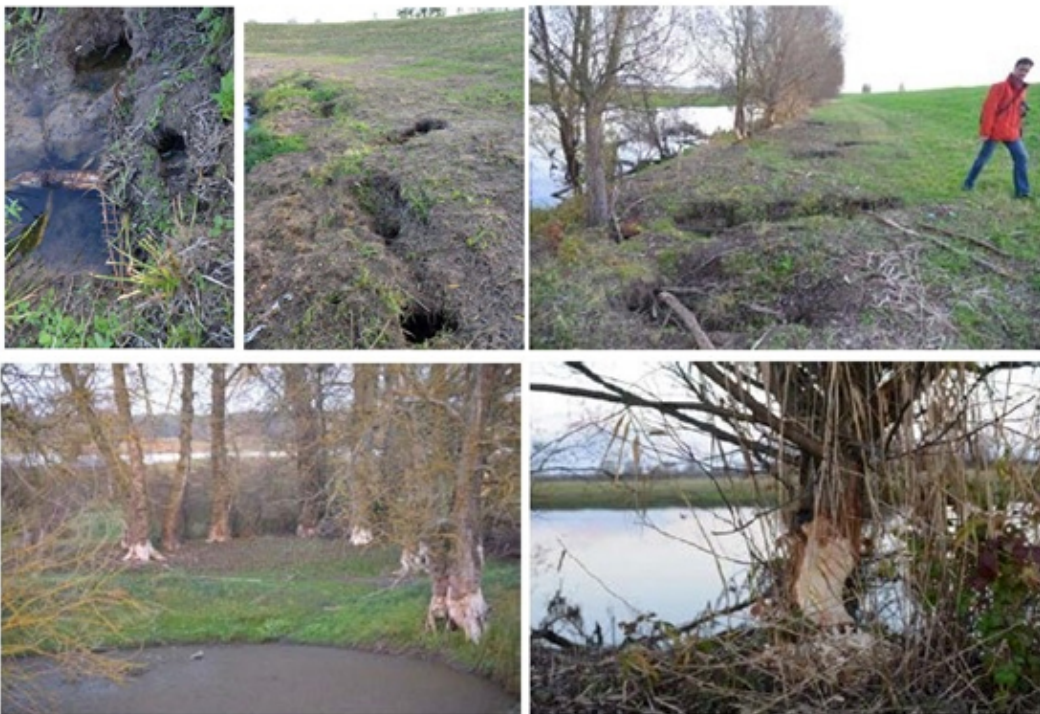
Figure 3. Effects of beavers in floodway encroachment zones along the Odra river in Sophienthal (Germany)

Measures to be undertaken to permanently prevent such effects depend on the sensitiveness of local authorities for potential hazards caused to people and to infrastructure, as well as on costs required for the interventions and on the sensitiveness for the endangered species. Most critical failures consist in partial or total collapse of the embankment by sliding. The correct approach consists in identifying critical areas of the dyke by observing the effects of their action in the encroachment zone (Fig.3).

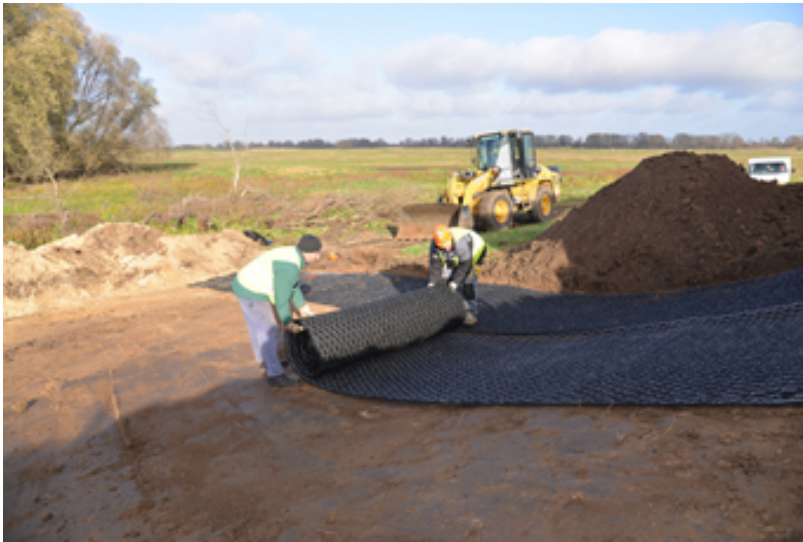
Figure 4. Installation of beaver netting

with a zinc-aluminum alloy and additionally by a polymer coating. The strength of the steel mesh will act as the impenetrable barrier for the rodents who will not be able to dig a hole through the steel net. The geomat will combine the anti-erosion function during flooding events and, by holding moisture, it will promote vegetation during the low flow season. These erosion mats may be delivered in rolled form and require very simple installation steps (Fig. 4).

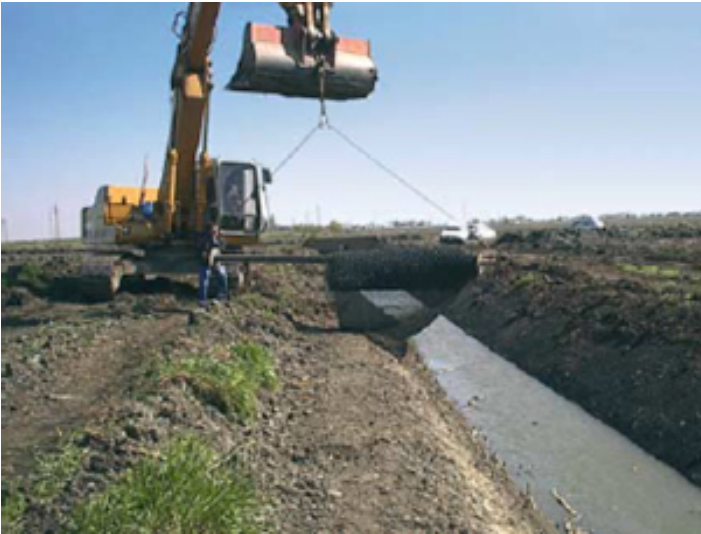
Figure 5. Installation of beaver netting along Zabarelle Canal

Based on these observations, the Ministry of the Environment, in coordination with the "National Institute for the Wild Fauna" and the ISPRA (Institute for the Protection and Environmental Research) financed a long-term research study aimed at monitoring canal banks after the installation of barrier systems against the intrusion of rodents [3]. A section of a drainage canal (Zabarelle) located in the Province of Rovigo (in an open floodplain of the river Po) was chosen as affected by significant presence of rodents and damages (Fig. 5).

Steel meshes, with and without an extruded geomat, were installed in test sections in 2003. The initial survey allowed the capture and marking of a number of nutria, and attachment of a GPS-transmitter, in order to trace their movements. Results soon indicated that marked animals had moved to other sections.
