Article Materials and Structures (2016): **RILEM TC 243-SGM: CONSOLIDATION OF RENDERS AND PLASTERS**

Table showing the most diffused damage symptoms occurring on historic plasters and renders.

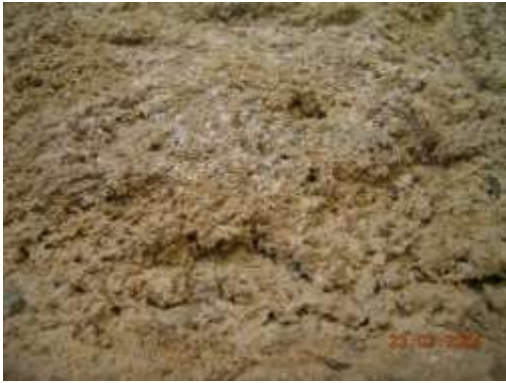
| Damage symptom | |
|--|--|
| <p>Crumbling</p> | <p>The particles of the material are no longer bound; the affected material is reduced to small lumps. Damage can start from the surface of the material or can be found in depth.</p> |

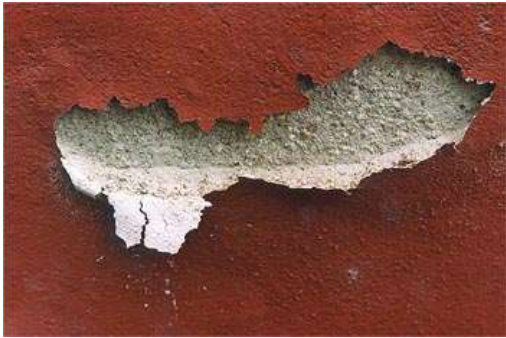
| Damage symptom | |
|--|--|
| <p>Sanding / Powdering</p> | <p>The particles of the plaster / render mortar are no longer bound; the affected mortar is reduced to sand. Damage starts from the surface of the material.</p> |

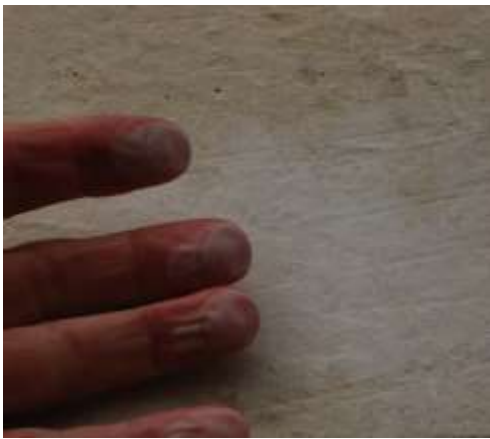
| Damage symptom | |
|--|--|
| <p>Chalking</p> | <p>The particles of a lime or gypsum layer are no longer bound; the affected material is reduced to very fine powder. Damage starts from the surface of the material.</p> |

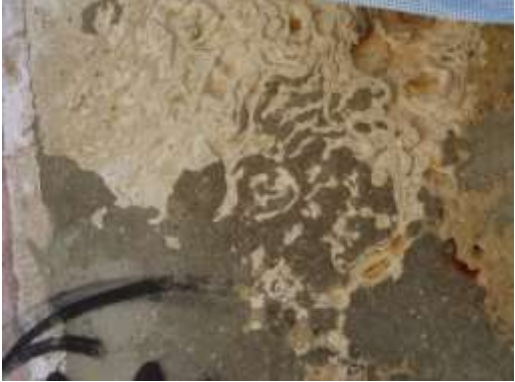
| Damage symptom | |
|--|--|
| <p>Alveolisation</p> | <p>The plaster shows a honey-comb like decay</p> |

| | <p>pattern, which may be caused by salt.</p> |

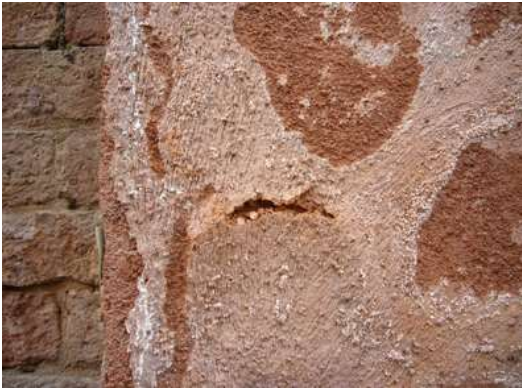
| <p>Bursting</p> | <p>Swelling of interior part of plaster together with disruption of the surface.</p> |

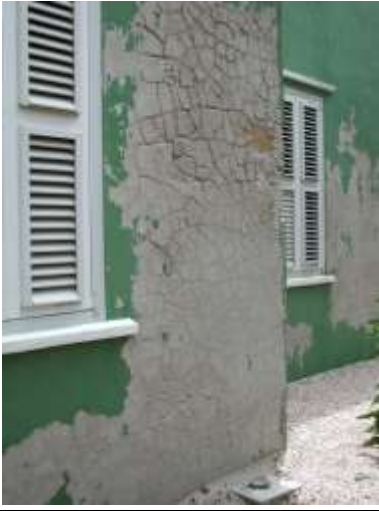
| <p>Crazing / craquelé</p> | <p>Craquelé is a network of minor cracks. The origin of the damage may be found in the drying shrinkage.</p> |

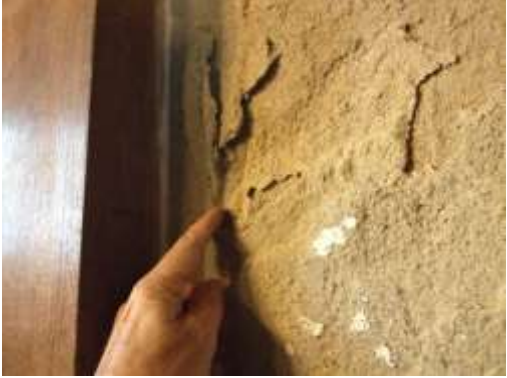
| <p>Exfoliation</p> | <p>Layering (more than one layer) of material with an originally not laminated structure.</p> |

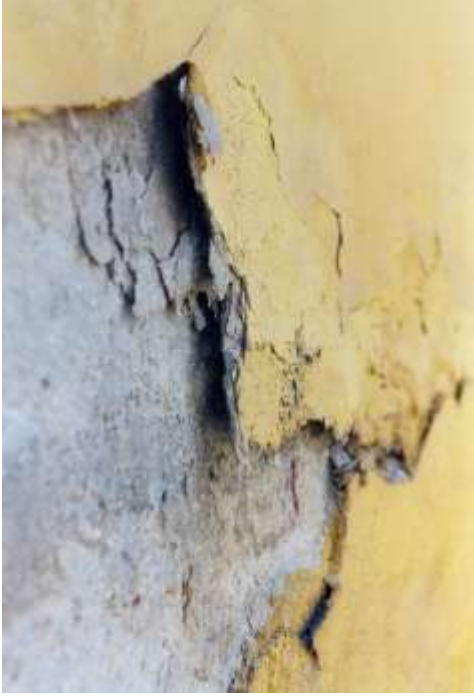
| <p>Delamination</p> | <p>Layering of material with an originally</p> |

| | <p>laminated structure, due to the type of plaster, applied in layers.</p> |

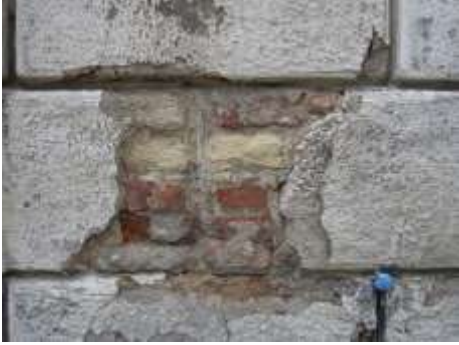
| <p>Loss of adhesion</p> | <p>The bond between (originally bounded) materials within the masonry is lost, e.g. the bond between rendering and masonry.</p> |

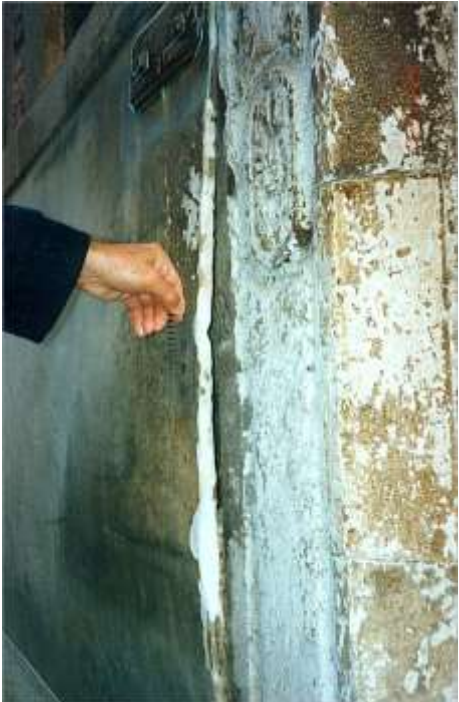
| <p>Bulging</p> | <p>Deformation of a rendering consisting in a deviation from its original form; the direction coefficient having changed, the shape of deviation is roughly a curve. It may appear together with cracking. The damage shows like a fat stomach.</p> |

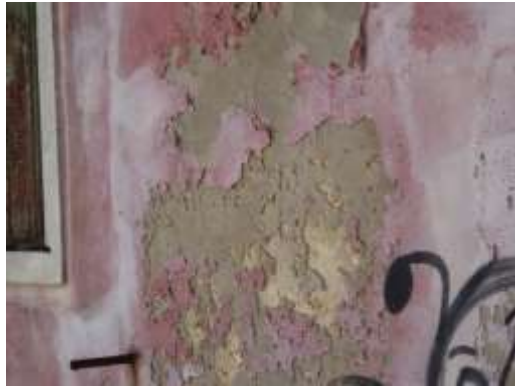
Peeling

Other than dome-like (see blistering, which is dome-like) detachment of paint or coating.

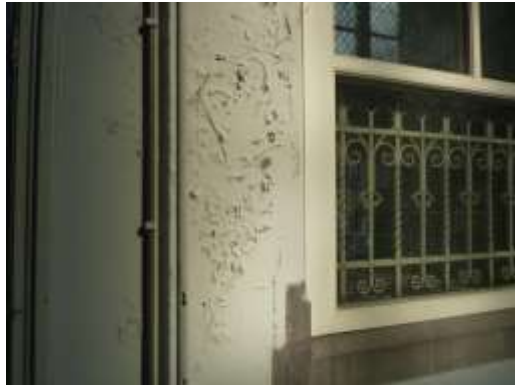
Blistering

Dome-like (cf. peeling, which is other than dome-like) detachment of paint, coating, or surface layer of masonry or plaster.

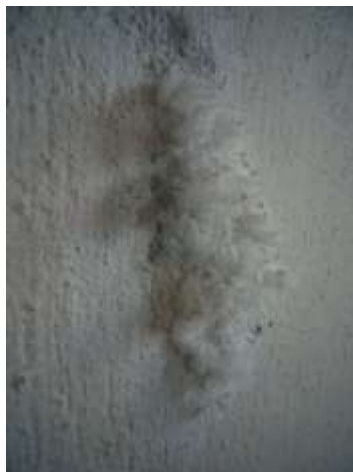
Efflorescence

Deposit of salt crystals visible on the original surface (see also crypto-florescence).

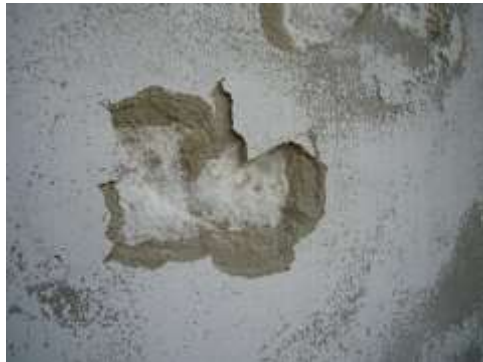
When not visible on the material surface (that is to say before any damage has occurred) a deposit of salt crystals (florescence) is called crypto-florescence (see also efflorescence). Crypto-florescence may lead to severe damage.
