**Feasibility study to determine if microfracture surgery using water jet drilling is potentially safe for Talar chondral defects in a Caprine model**

# Feasibility Study to Determine if Microfracture Surgery Using Water Jet Drilling Is Potentially Safe for Talar Chondral Defects in a Caprine Model

CARTILAGE  
2021, Vol. 13(Suppl 2) 1627S–1636S  
© The Author(s) 2019

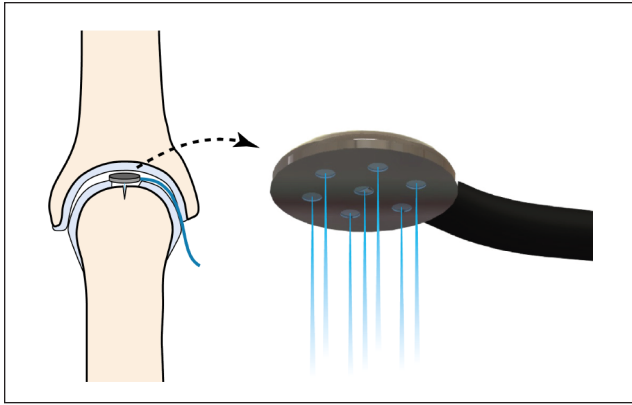
**Figure 1.** Graphic illustration of the proposed minimally invasive water jet surgical instrument. The flexible tubing that offers the water/saline supply facilitates the reachability in the tight joint spaces and the nozzle head can be designed such that it allows multiple water jets to be jetting simultaneously. As can be seen in the left picture, the opposing surface layer can act to offer the counterforce needed for the recoil and stable jetting.

The next steps in the development of the water jet drilling technique will be the design of a medical pump that offers stable high pressures and a flexible arthroscopic water jet drill that is suitable for performing microfracture during an arthroscopic procedure (Fig. 1). For the former the build-up and maintenance of constant high pressure is crucial, as highlighted by this study. For the latter, consistent water jet beam coherence, stability and recoil resistance of the nozzle head

are imperative to increase reproducibility and reliability of the water jet drilling (**Fig. 1**). Finally, the results highlight the need to minimize water use and backsplash in order to decrease soft tissue extravasation of fluid. Several experimental studies have shown that this can be achieved with limited jet times or changing the nozzle diameter.<sup>8,26,38</sup> Once all these technical improvements are implemented, the development of the intended arthroscopic water jet surgical instrument should be tested in a solid noninferiority study.

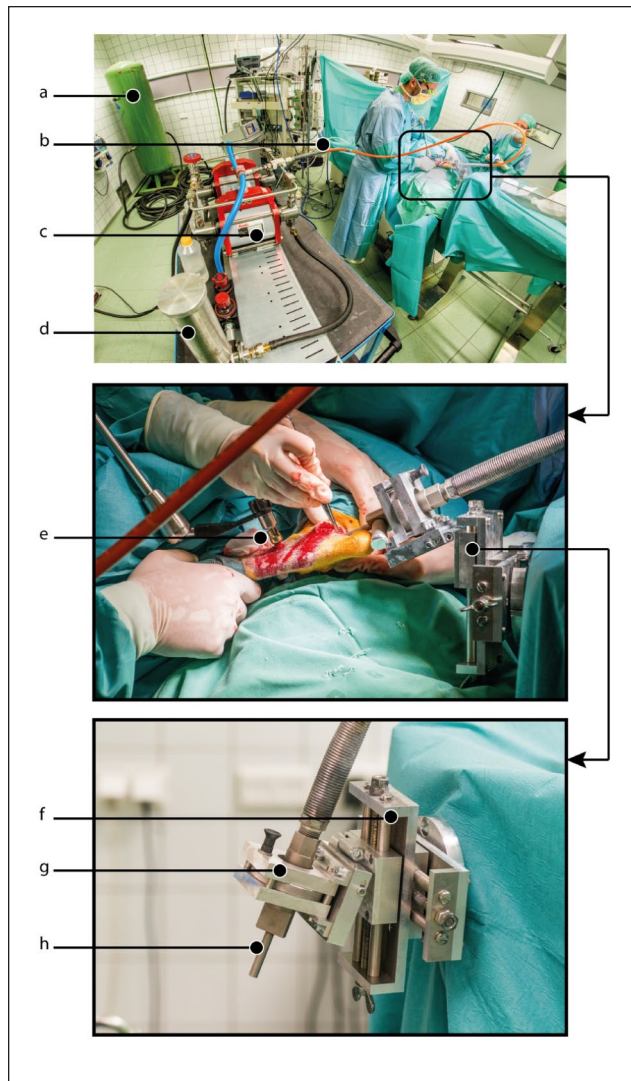
**Figure 2.** Overview of the complete water jet set up in the operating room. Top: overview of operating theatre. Center: water jet alignment of the water jet instrument with the defect in the talar bone and external fixator to fixate the goat's leg to the operating table. Bottom: alignment tool and water jet nozzle head. (a) 300-L accumulator; (b) high-pressure tube; (c) air-driven water pump; (d) water container; (e) fixating screw for the goat leg; (f) omnidirectional alignment support for nozzle head; (g) off-center turning wheel; (h) nozzle head.

Water jet drilling was performed by using a custom-made setup. An air compressor connected to a 300-L accumulator was used to power the air-driven high-pressure pump (P160 Resato, Roden, Netherlands, [www.resato.com](http://www.resato.com); **Fig. 2**) offering a water pressure of 50 MPa. Sterile 0.9 % saline infusion fluid was used to feed the pump with a custom-built water container. This is the same fluid used during conventional arthroscopy for fluid management. However, notice that the pressures for routine irrigation (50-113 mm Hg equal to 7-15 kPa) are a factor 1000 lower compared with the setting in this study.<sup>37</sup>

All parts of the pump that would come into contact with saline were sterilized at 134°C and assembled under sterile conditions at the operating theatre. The pressurized saline was fed through a high-pressure hose (Holmatro, Raamsdonksveer, Netherlands) into a custom-made nozzle head consisting of a straight tube with a 0.4-mm diameter

sapphire nozzle (Salomon Jetting Parts B.V., Maasdam, Netherlands). Using a low-pressure water stream, the nozzle head was aligned perpendicularly to the defect in the talar bone and fixed using a custom-made support structure that allowed omnidirectional movement (Fig. 2). As it appeared that the alignment of the talar bone was slightly disturbed during a water jet burst, it was necessary to rigidly fixate the leg of the goat. This was achieved by introducing a predrilled 8 mm screw in the tibia (Fig. 2e). To this end, a stab incision was made away from the primary surgical site.

The screw was attached to an external existing fixator, which was connected to the operating table. Four to six holes were created per defect using a 0.4-mm diameter water jet burst lasting 5 seconds at a pressure of 50 MPa.<sup>25</sup> These machine settings were chosen as such to ensure that the power of each water jet was unquestionably sufficient to drill a hole through the subchondral bone layer. We based this on our previous research, where we water jet drilled in bones with varying mineral densities using numerous machine settings, and determined the drilling depth with micro-computed tomographic analyses.<sup>25,26,38</sup> An even distribution was achieved by turning the nozzle head in plane with an off-center turning wheel following each burst. The saline pressure was monitored using the integrated pressure gauge at the pump.

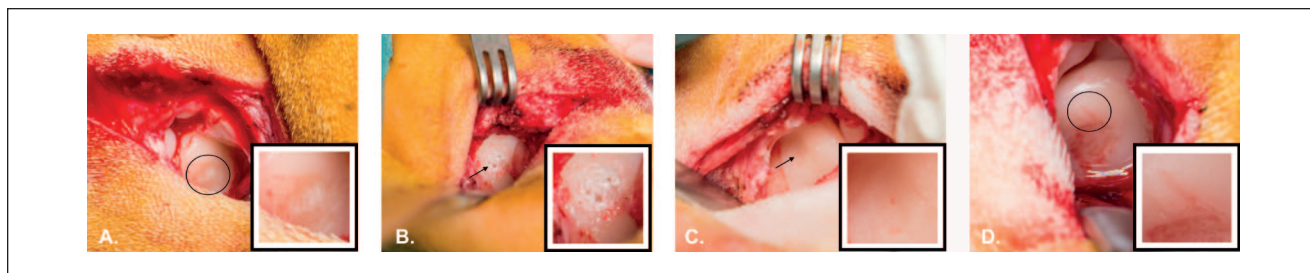
**Figure 3.** Perioperative photographs. **(A)** The chondral defect created before treatment. **(B)** A chondral defect treated with conventional microfracture. **(C)** A chondral defect treated with water jet. Blood droplets can be seen in the hole. **(D)** An undesired abrasion on the rim of the defect caused by the water jet recoiling due to insufficient fixation of the talar bone.

In 4 out of the 6 cases, the 4 to 6 water jet–drilled holes were visible after treatment in a comparable manner as the holes created with conventional microfracture (**Fig. 3B** and **C**). In the first 2 cases, only 2 water jet–drilled holes were clearly visible.

after treatment with either surgical technique, since the initial chondral defect with intact subchondral bone layer did not show any bleedings (Fig. 3A vs. 3B and C). Therefore, water jet drilling introduces sufficient blood for the formation of fibrous repair tissue, even in this setup with its limitations. Postoperative imaging to confirm the water jet holes, using computed tomography scans for example, could have provided an objective assessment, but were deemed an unnecessary burden for the animals since extensive imaging in *ex vivo* studies has shown the ability of water jet to machine bone when the technique is used correctly.<sup>8,25,26,38,48</sup>

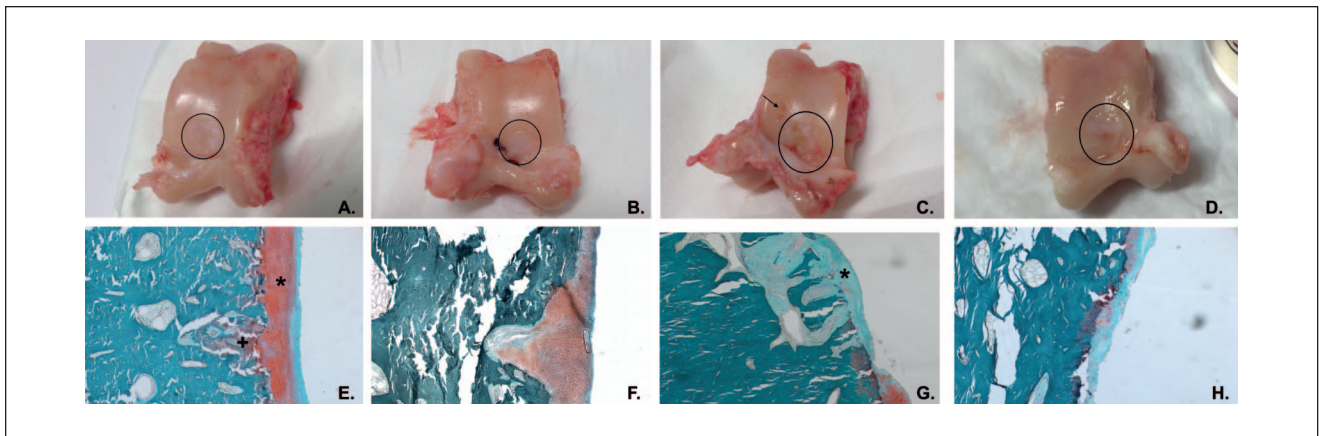
**Figure 4.** Representative examples of the macroscopic and microscopic analyses. **(A)** A defect filled with repair tissue treated with water jet that resulted in a good ICRS (International Cartilage Repair Society) macroscopic score. **(B)** A defect filled with repair tissue treated with conventional technique that resulted in a good ICRS macroscopic score. **(C)** A defect treated with water jet that resulted in a poor ICRS macroscopic score. Unintended water jet abrasions in the cartilage outside the defect are also seen (arrow). **(D)** A defect treated with conventional technique that resulted in a poor ICRS macroscopic score. **(E)** A safranin-O-stained histological slice, magnification 100 $\times$ , corresponding to the sample in **A** (water jet), with average staining (+). A perforation of the subchondral layer is also visible (\*). **(F)** A safranin-O-stained histological slice, magnification 100 $\times$ , corresponding with the sample in **B** (water jet) with poorly stained fibrous tissue (\*). **(G)** A safranin-O stained histological slice, magnification 100 $\times$ , corresponding with the sample in **C** (conventional microfracture) with little staining (\*), but a regular surface appearance. **(H)** A safranin-O-stained histological slice, magnification 100 $\times$ , with poorly stained fibrous tissue and a fibrillated surface.

Last, in 1 case the surgery had to be cancelled after anesthesia due to insufficient pressure build-up of the water jet pump to perform the treatment. The surgery was rescheduled and performed 1 week later after resolving the issue. Figure 4 shows representative macroscopic and histologic samples of the best and worst cases of each of the 2 surgical techniques.

10 for observer 2) with severe fissures in the macroscopic appearance and minimal integration into the adjacent healthy cartilage (Figs. 4 and 5). The modified O'Driscoll score histological score did not show this difference but resulted in an average quality repair tissue for both tali. Therefore, it is more likely that this degraded aspect was caused by cartilage abrasion by the water jet recoil and subsequent motion of the nozzle head rather than related to the extravasation. Reliable positioning and recoil resistance of the water jet are imperative to optimize the water jet setup.

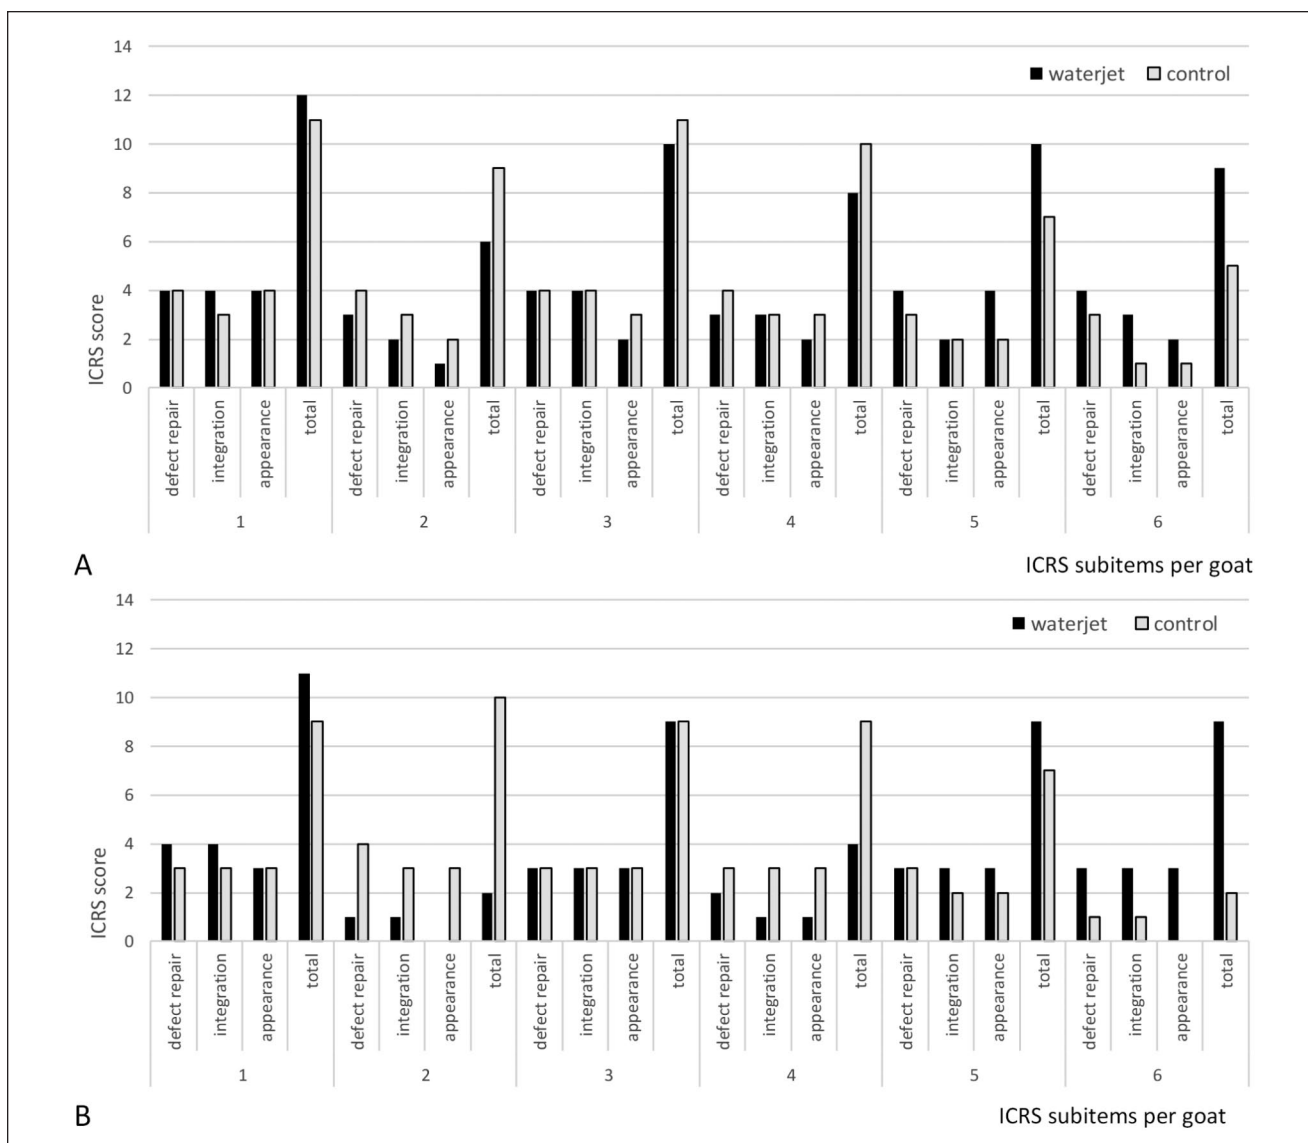
**Figure 5.** ICRS (International Cartilage Repair Society) subitems and total score for each individual goat. **(A)** Observer 1. **(B)** Observer 2. The water jet treatment is shown in black bars and the conventional microfracture treatment in gray bars.

The median total ICRS score for the water jet tali was 9.5 (range: 6-12) for observer 1 and 9 (range 2-11) for observer

2 (**Fig. 5**). For the conventional microfracture group the median ICRS score was similar: 9.5 (range 5-11) and 9 range (2-10) for observers 1 and 2, respectively (**Fig. 5**).

The one case in our study where the extravasation was particularly present also showed a low ICRS macroscopic score for both observers compared with the contralateral, conventionally treated, talus (6 vs. 9 for observer 1 and 2 vs.

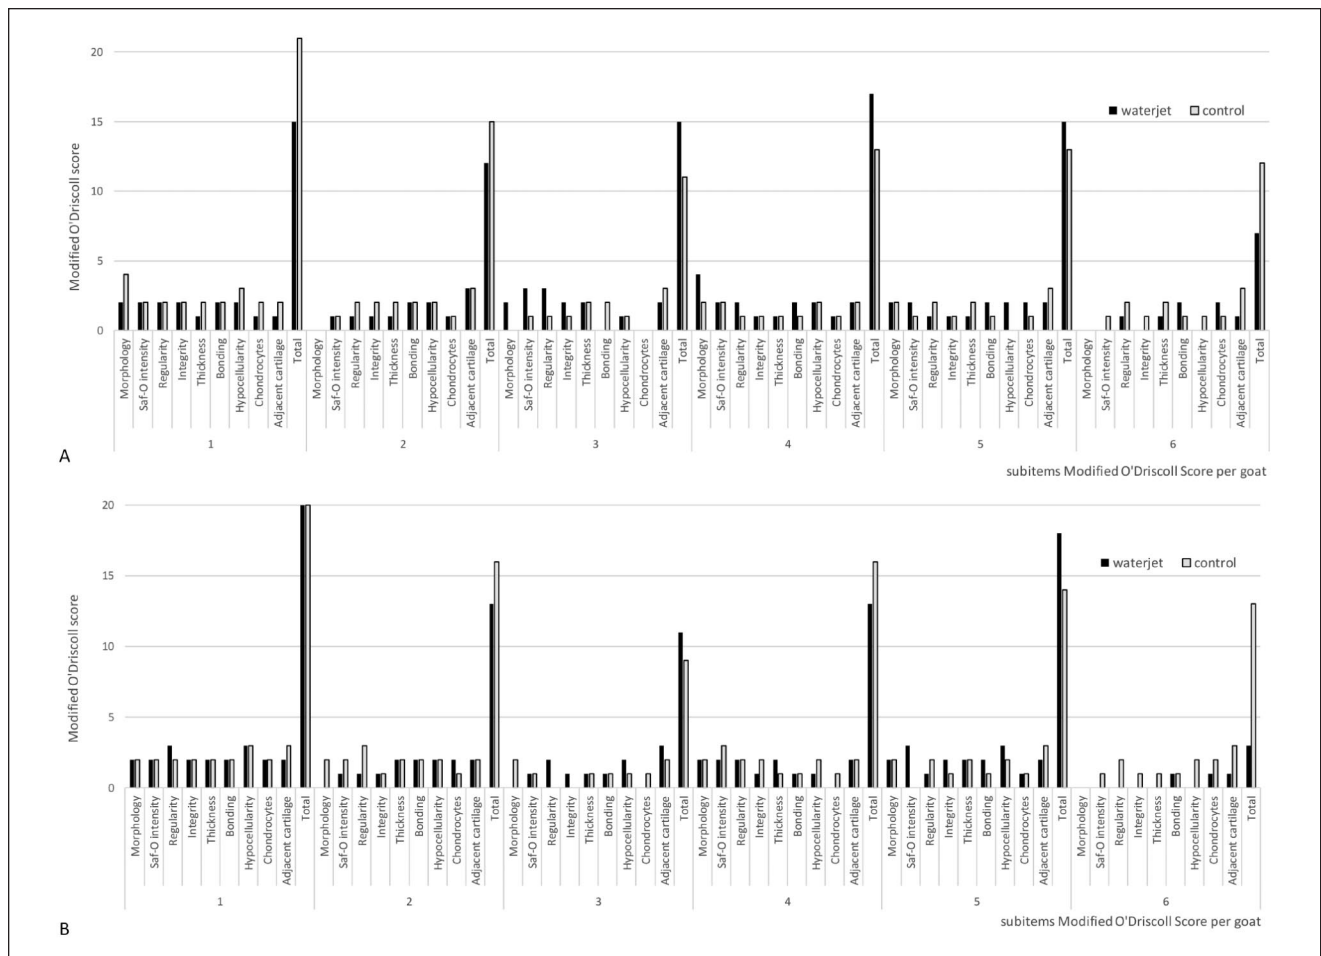
**Figure 6.** The modified O'Driscoll scores for each individual goat. (A) Observer 1. (B) Observer 2. The water jet treatment is shown in black bars and the conventional microfracture treatment in gray bars for the total modified O'Driscoll score.

The median total modified O'Driscoll score for the water jet tali was 15 (range: 7-17) for observer 1 and 13 (range: 3-20) for observer 2 (**Fig. 6**). The control group median total modified O'Driscoll score was 13 (range: 11-21) and 15 (range: 9-20) for observers 1 and 2, respectively (**Fig. 6**). Note that for observer 1, the subitem repair cartilage thickness showed 1 out of 6 samples scoring 100% thickness in the water jet group versus 5 out of 6 samples in the conventional microfracture group. The remaining samples in both groups scored 50% to 100% thickness (5 samples versus 1 sample, respectively).
