## Determination of the shear strength of tropical hardwood timber

WCTE 2016 - World Conference on Timber Engineering

# DETERMINATION OF THE SHEAR STRENGTH OF TROPICAL HARDWOOD TIMBER

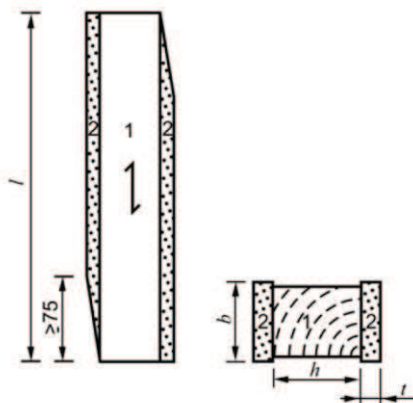
**Key**  
 1 grain direction  
 2 steel plate  
 3 timber test piece

**Figure 1:** Timber test piece with glued on steel plates according to EN 408.

The test set-up according to EN 408 is used for the experiments. The intention is to determine the “pure” shear strength with as little interaction with other stresses as possible. Tapered glued steel plates of 10 mm thickness are glued on both sides. See figure 1. The test piece is positioned at an angle of 14 degrees with the loading direction in the test set-up. See figure 2.

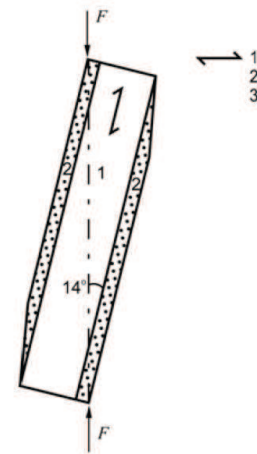
**Key**  
 1 grain direction  
 2 steel plate  
 3 timber test piece

**Figure 2:** Loading arrangement of the test piece according to EN 408.

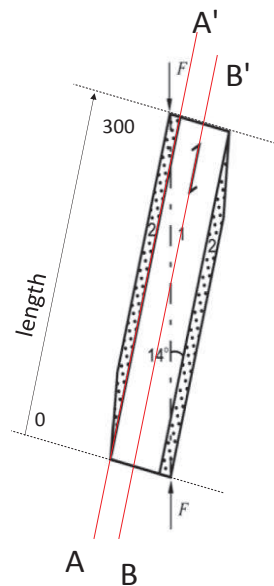
*Figure 3: Indication of cross sections AA' and BB' for which the stresses are shown in figures 4 to 9.*

Figure 3 shows the cross sections for which the stresses are shown in figures 4 to 9. The shear stresses in the glue line in cross section AA' of figure 3 are shown in figure 4 for softwood and figure 7 for hardwood. The normal stresses perpendicular to the grain in cross section AA' of figure 3 are shown in figure 5 for softwood and figure 8 for hardwood. The shear stresses in the middle of the timber pieces in cross section BB' of figure 4 is shown in figure 6 for softwood and figure 8 for hardwood.

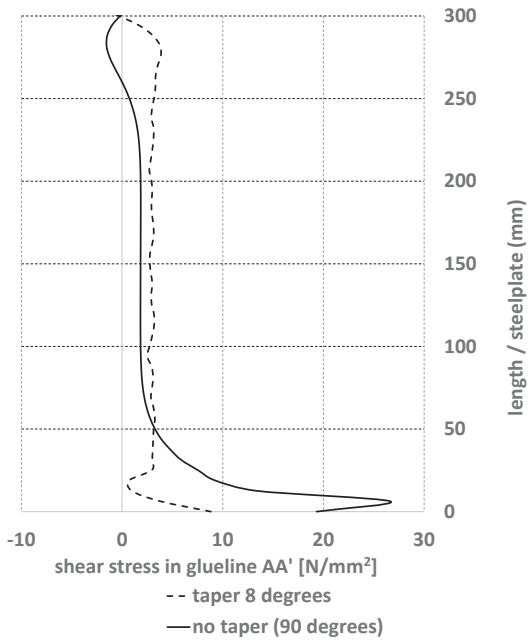
Figure 4: Shear stress in the glue line AA' for softwood.

- The application of the taper gives an almost evenly distributed shear stress in the glue line with the steel plate over the length of the steel plate, although at the taper the shear stress increases.
- Tension stresses perpendicular to the grain almost not occur, both for the tapered and the non-tapered configuration
- The taper gives a more evenly distributed shear stress in the middle of the timber.

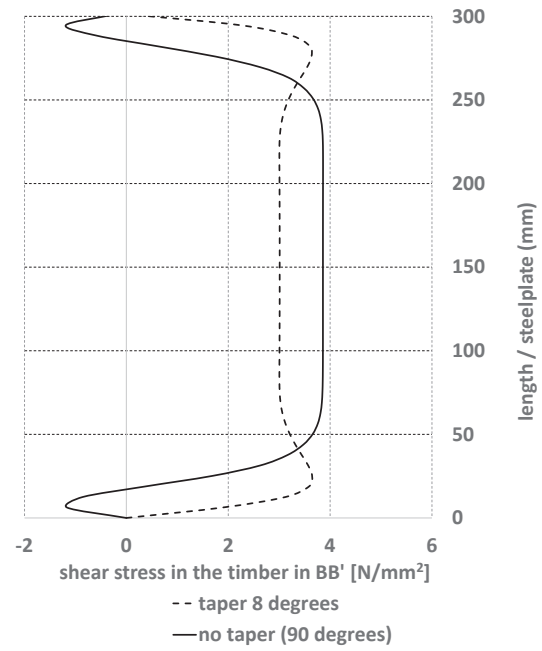
Figure 6: Shear in the timber in BB' for softwood.

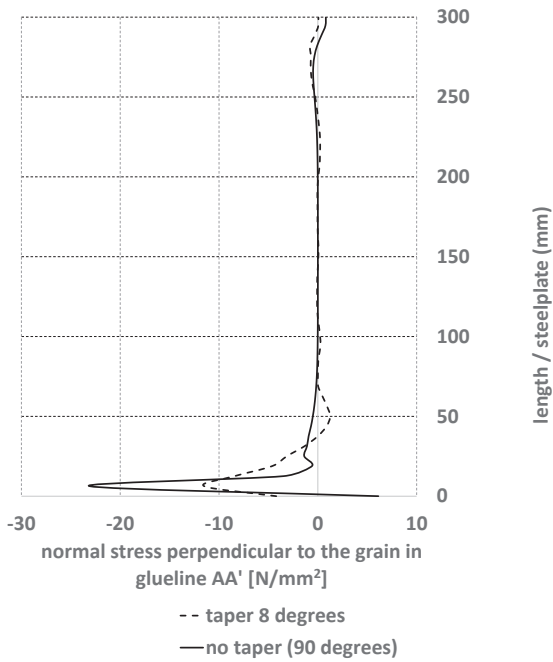
Figure 5: Normal stresses perpendicular to the grain in the glue line AA' for spruce.

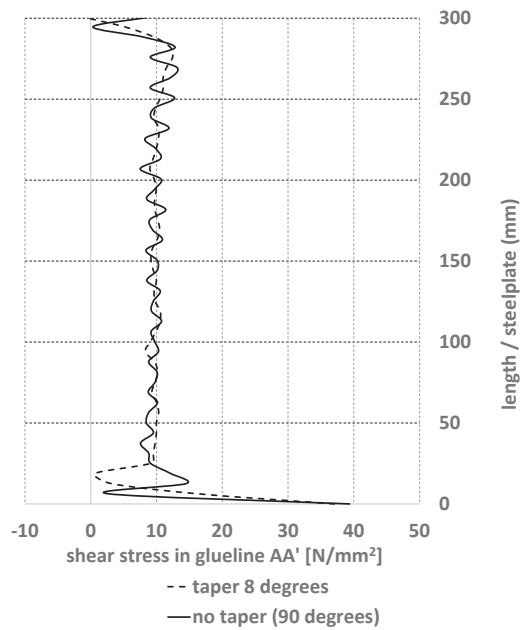
Figure 7: Shear stress in the glue line AA' for hardwood

- Peak shear stresses occur for both tapered and non-tapered steel plates at the interface.
- For the non-tapered steel plates peak tension stresses perpendicular to the grain may occur.
- For the shear stress in the middle of the timber there is not much difference in the shear stresses between the two configurations.

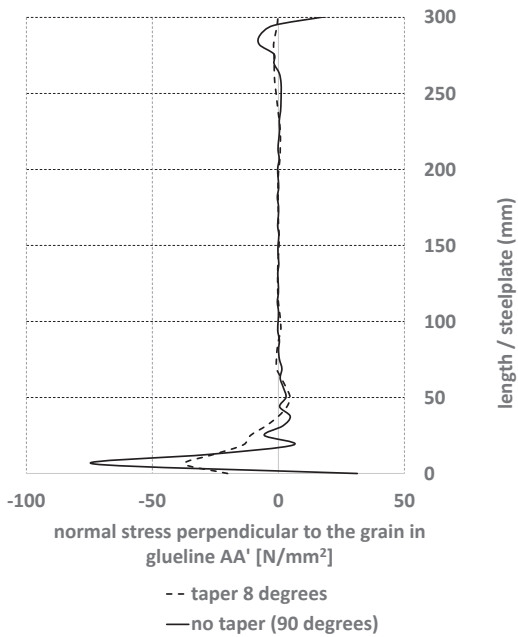
**Figure 8:** Normal stresses perpendicular to the grain in the glue line AA' for hardwood.

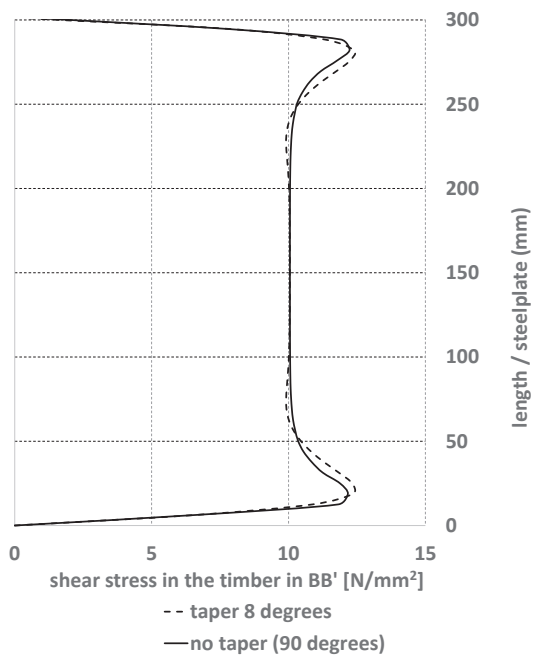
**Figure 9:** Shear in the timber in BB' for hardwood.

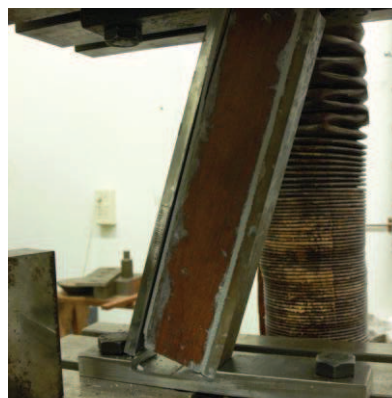
**Figure 10:** Massaranduba specimen: Failure of 100% in the glueline.

In figures 10 to 12 typical failure modes are shown.

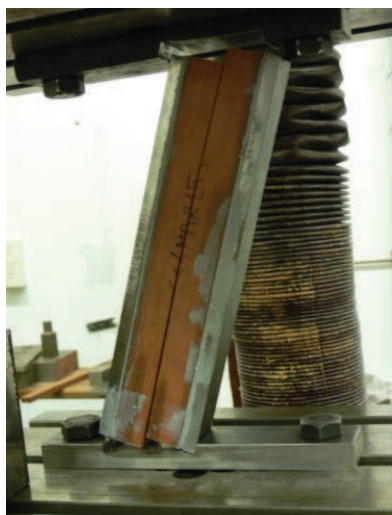
**Figure 11:** Massaranduba specimen: Failure of 0% in the glueline.

The 4 pieces with the lowest strength values had 0% failure in the interface (see figure 11), and were all cut from the same massaranduba beam.

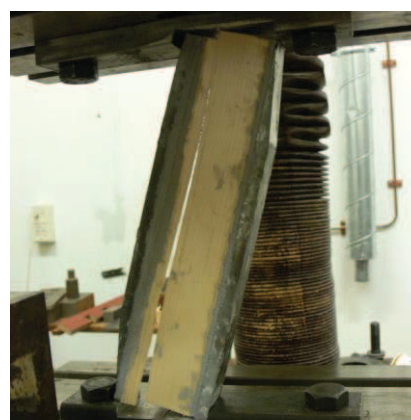
**Figure 12:** Spruce specimen: Failure of 0% in the glueline.

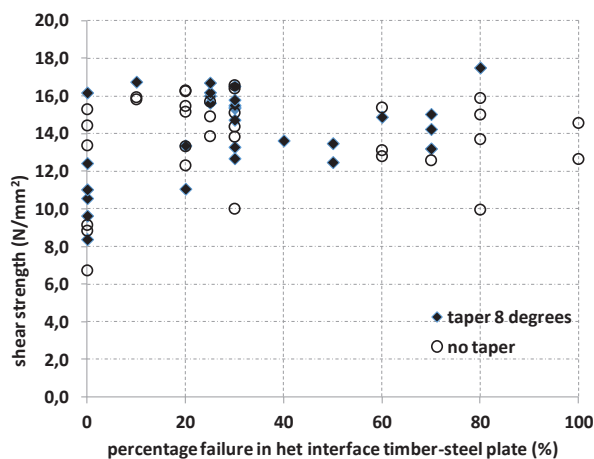
**Figure 13:** Shear test results for massaranduba plotted against percentage failure in the interface divided in to specimens with and without tapered steel plates.

Table 5 and figure 13 indicate that the application of the taper to the steel plates had no effect on the shear strength values and the percentage failure in the interface. This might be caused by the fact that the glue, the Sikadur 30 is applied with 3 mm thickness, in

contrast to the FEM calculations, where a zero thickness was assumed. This thickness of 3mm might reduce the peak stresses in such a way, that the effect of the taper diminishes.

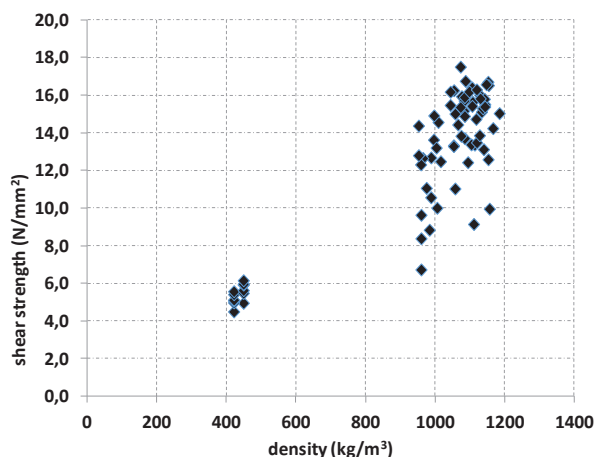
**Figure 14:** Relationship between the shear strength and the density for the spruce and massaranduba specimen.

Figure 14 suggests a constant ratio between the shear strength and the density of the two wood species..
