## Experimental method for investigating wear of porous thermal insulation systems exposed to realistic, hot, turbulent gas flow

Wear

# Experimental method for investigating wear of porous thermal insulation systems exposed to realistic, hot, turbulent gas flow

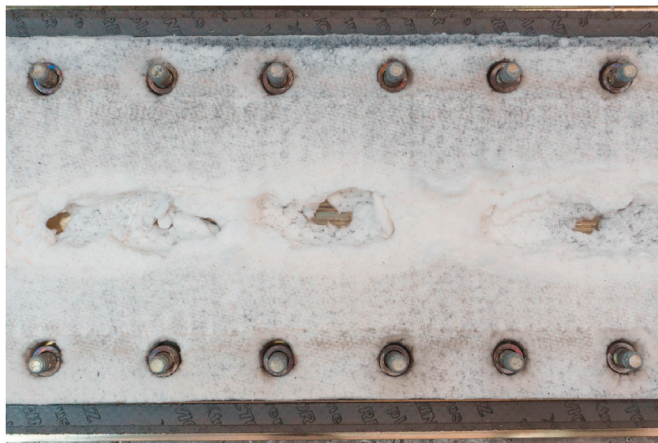
Fig. 14. Distributed insulation damage, photograph taken from the flow side with the liner removed.

In most cases however, the tested insulation systems had distributed insulation damage, which is the type that can be better correlated with the mass change. Fig. 14 shows an example. With such extensive wear, the mass change can be corrected for the presence of shot chunks in the worn region, as they remain as residue at the bottom of the sample container. This can be done by determining their mass separately after
