**Root causes of failures in sustainable urban drainage systems (SUDS)
an exploratory study in 11 municipalities in the Netherlands**

Blue-Green Systems

Root causes of failures in sustainable urban drainage systems (SUDS): an exploratory study in 11 municipalities in the Netherlands

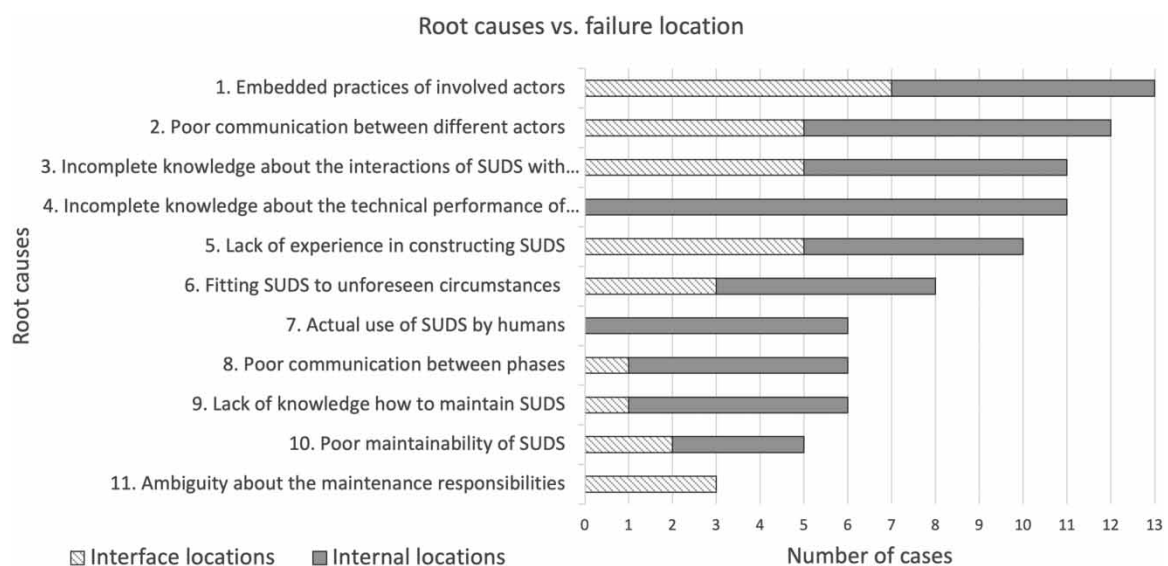
Figure 10 | Number of failures in SUDS failure location, for each root cause.
