ADVANCES IN COASTAL DISASTERS RISK MANAGEMENT – LESSONS FROM THE 2011 TOHOKU TSUNAMI

Sebastian N. Jonkman¹, Tomohiro Yasuda², V. Tsimopoulou³, H. Kawai⁴ and F. Kato⁵

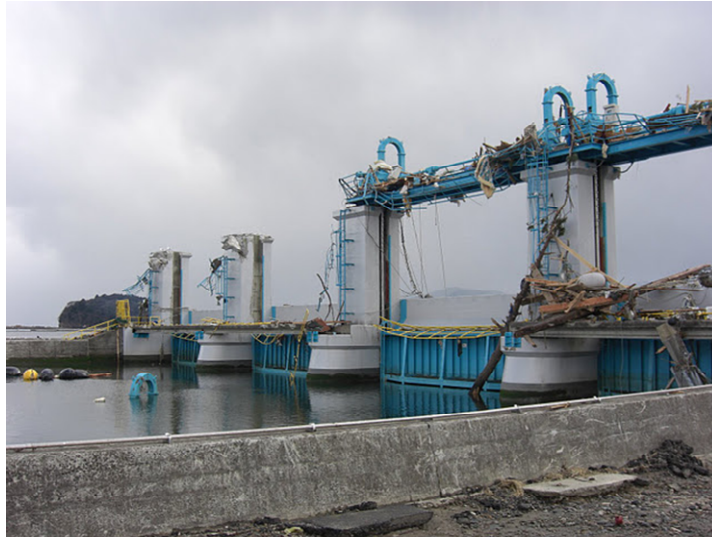
Figure 2: Damaged floodgate at Minamisanriku

The field observations give empirical support for the tsunami loading on structures such as breakwaters, coastal dikes and tsunami walls, and the resistance and failure modes of these structures in extreme conditions. More specifically, phenomena such as scouring, wave reflection and impulsive loads as a function of time can be better understood by analyzing the observations. Even 10 m high solid concrete walls failed due to the enormous impact. As part of the protection system floodgates were in place at locations where rivers flowed into the ocean (See Fig. 2). Not all floodgates could be closed during the disaster, due to the earthquake and the limited time available before arrival of the tsunami wave. Some of the floodgates were also structurally damaged due to the event.

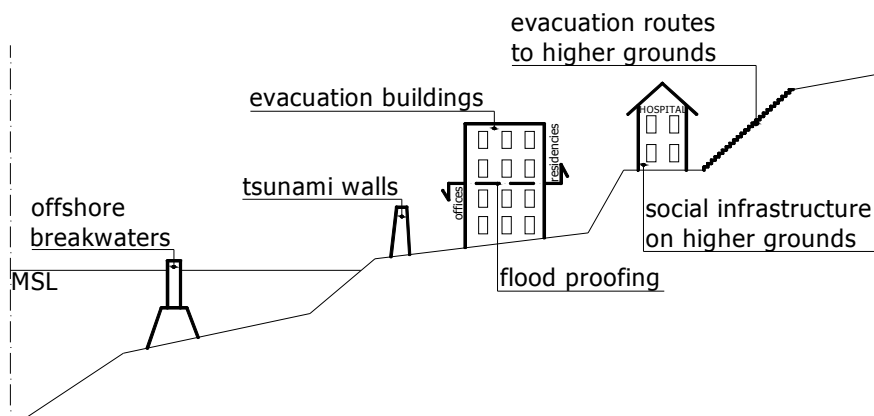
Figure 3: Typical measures for tsunami risk reduction along the Rias type coast (bays) (Tsimopoulou, 2012).

Both in the Netherlands and Japan, it is under discussion how multiple levels or layers of protection (coastal defences, land use planning and emergency management) can contribute to a reduction of risks from storm surges and tsunamis (see also Fig. 3). Related concepts have been developed in other parts of the world, e.g. “multiple lines of defence” in New Orleans. Information and experiences from the March 2011 tsunami can be used to a) evaluate the performance of such a multilayered risk reduction system; b) to develop effective strategies to reduce future risks. At this moment, discussions are ongoing on appropriate redevelopment and risk reduction strategies for the areas affected by the tsunami. The figure below gives an example of a proposed strategy for the Sendai area.

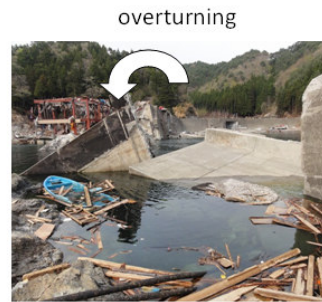
Ryoishi Coast (Iwate Prefecture)

(2) Overturning of seawall

Figure 4: Overturning of seawalls during the March 2011 tsunami event (Presentation F. Kato, this seminar).

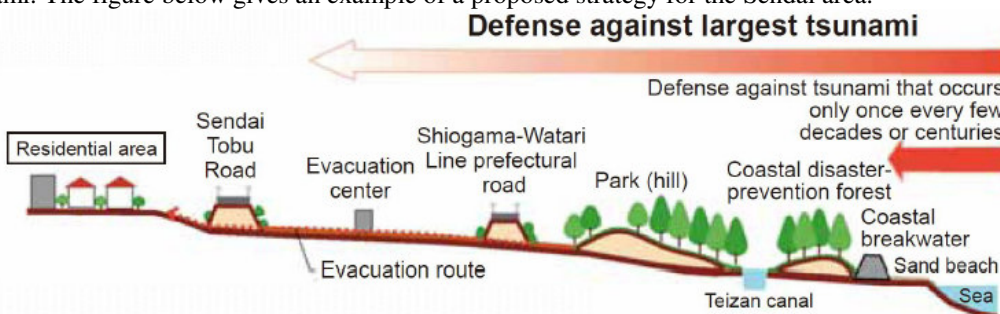
Figure 5: One of the proposed strategies for the future protection on the Sendai coastal area (Presentation S. Koshimura, this seminar).
