**SSC-272**

**IN-SERVICE PERFORMANCE  
OF STUCTURAL DETAILS**

"Structural Details Failure Survey"

IN-SERVICE PERFORMANCE OF STRUCTURAL DETAILS

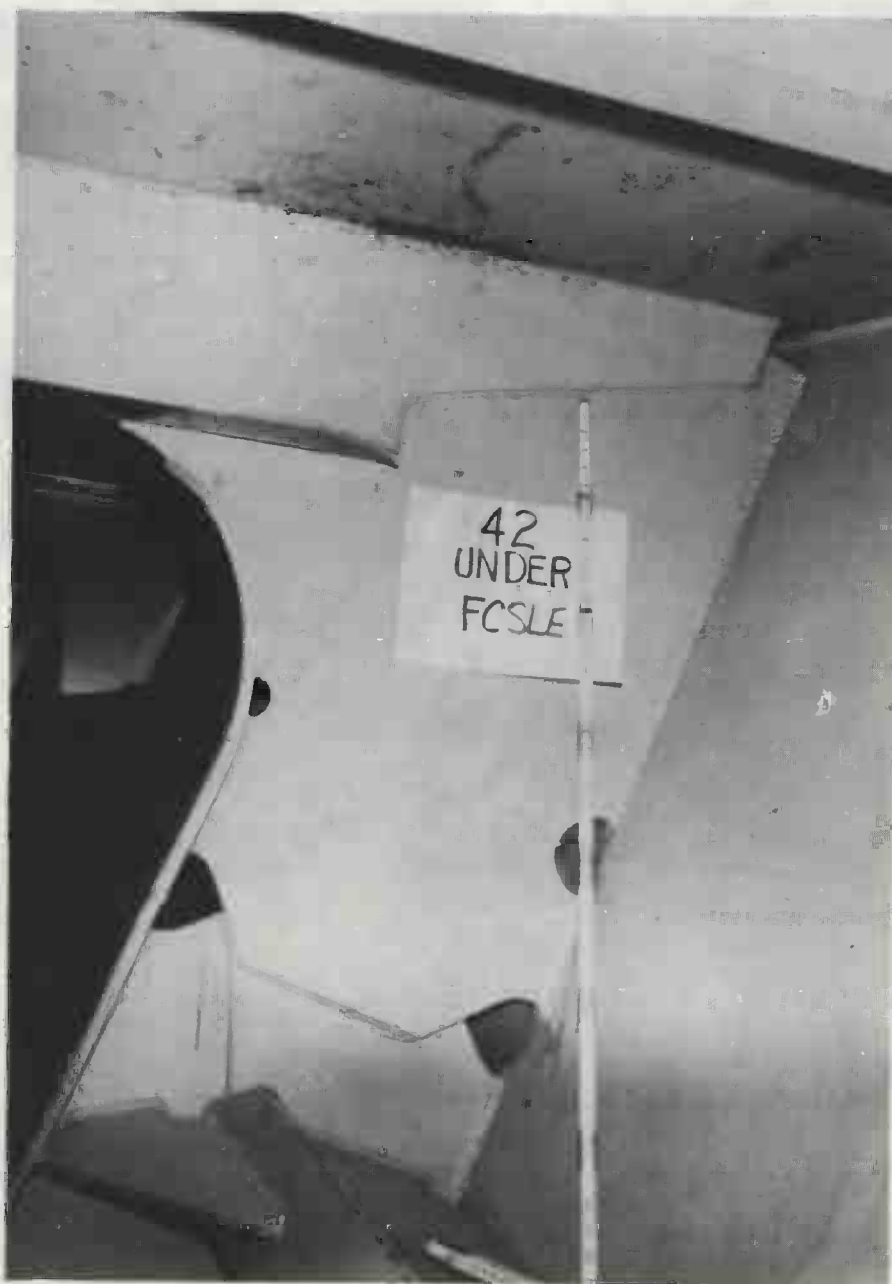
FIGURE 24

Reasons for failed fabrication laps were not readily apparent. Heavy weather conditions were suggested as a cause for three or four cracks at the openings. Most of the cracks, however, were due to a poor fitting, welding, eccentric forces due to the laps, and other reasons not apparent in the physical and design detail environment. A sample of a sound lap detail is shown in Figure 24 which also shows other miscellaneous cutouts in this detail family.

LAPPED WEB CUTOUTS AND OTHER  
STRUCTURAL DETAILS IN A BULK CARRIER

This picture is of the upper portion of a web frame supporting the side shell and forecastle deck.

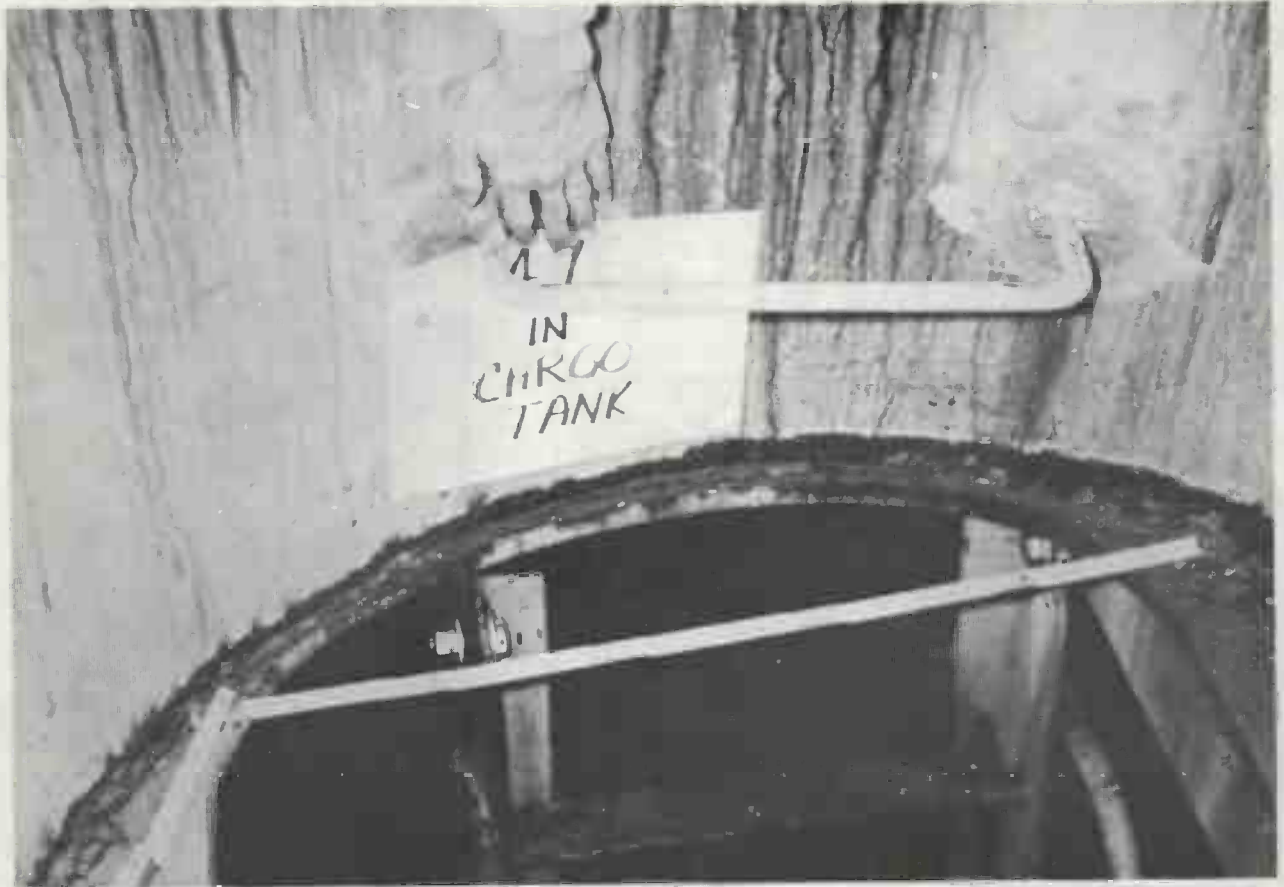
FIGURE 39

SAMPLE DECK CUTOUT ON A TANKER

The picture is on the forward end of a main cargo tank access opening in upper deck. This particular tank was relatively free from corrosion but note the renewed bolts holding the clips to the ladder. This opening, similar to detail 9-A-8, has no failure.

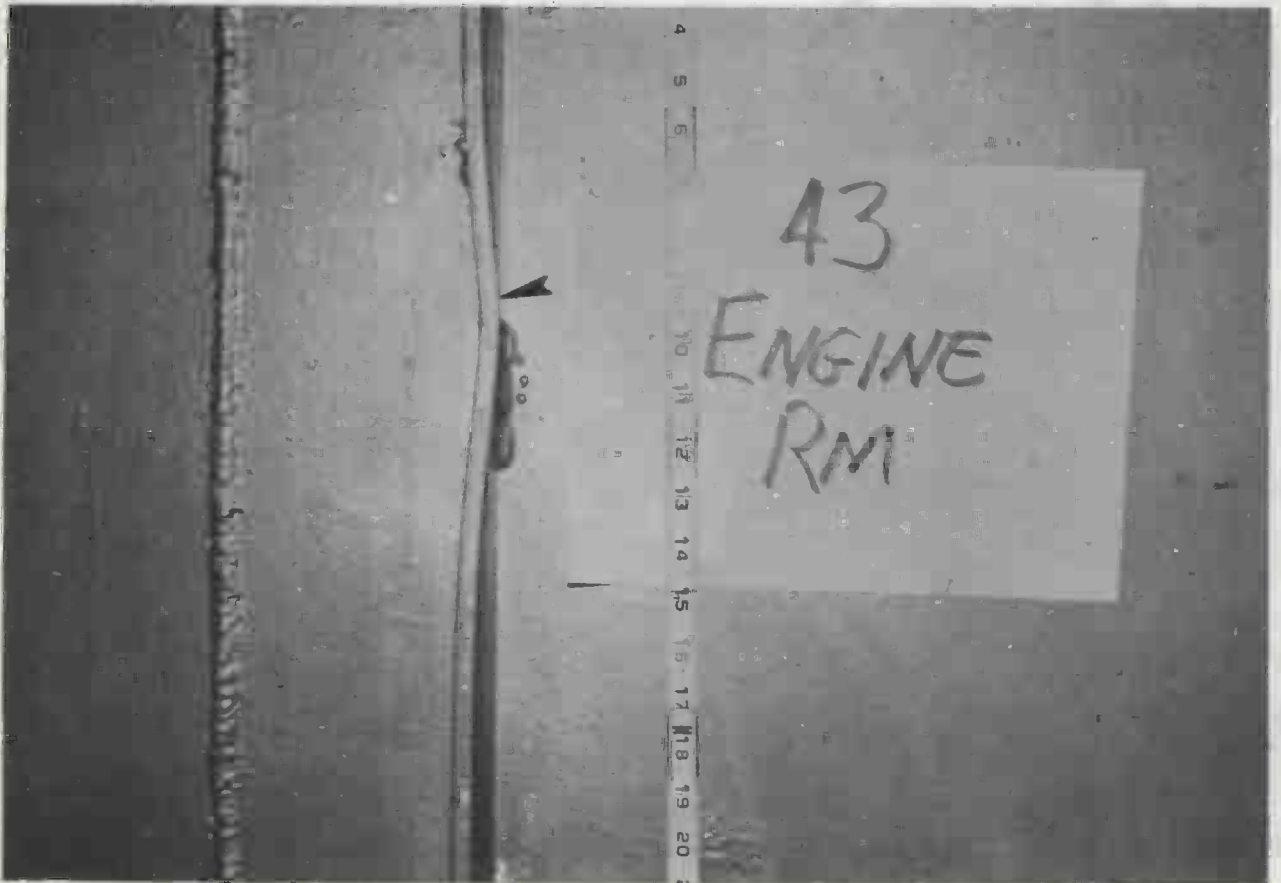
FIGURE 53

The photograph in Figure 52 shows a crack similar to detail 1201 in Figure 51. These cracks occurred on the bottom of cargo tanks as well as at mid depth. Figure 53 shows a buckled flat bar stiffener which has been subject to an unusual and local horizontal load on a miscellaneous bulkhead. Figure 54 contains a photograph of a reinforced panel stiffener on a transverse hatch coamway.

BUCKLED PANEL STIFFENER ON A GENERAL CARGO SHIP

The photograph shows the buckled position of a detail 12-C-5 flat bar panel stiffener on a girder web. The 26" x 4" girder was laterally displaced resulting in the buckled panel stiffener.
