Effect of Kinetic Energy due to Hail Impact on Damage Evolution in Gelcoated Glass Fibre Reinforced Polymer Composite

AE5711: Thesis Aerospace Structures and Materials Saran John Vaseekaran

Thesis committee:Dr. ir. C.D.RansTDr R.M.GrovesTDr ir J.J.E TeuwenTProject Duration:March 2022, - January , 2023Faculty:Faculty of Aerospace Engineering, Delft

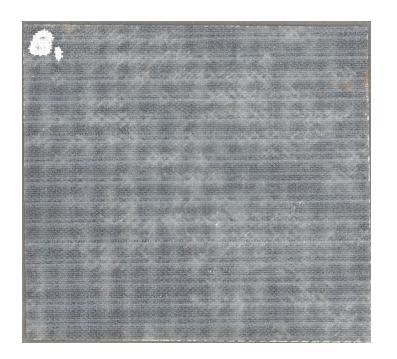
All the samples were subjected to visual and microscopic inspection before impact on the Coated side(outer edge) and non coated sides (inner edge) of the sample to check for any damages before commencing the test. The samples exhibit vertical and horizontal white lines and no other obvious manufacturing defects, as seen in Figure 4.5. The horizontal and vertical lines indicate the stitches used to hold non-crimp fibre layers in place and are visible due to the transparent matrix used. Other defects, such as porosity and delamination, would be identified by C-Scan. It is pertinent to mention that the c-scan images showed the presence of no voids or delamination in the samples except for the sample used for the impact test for the 18 mm SHI impacted with an average velocity of 100 m/s.

Figure 4.5: Image of non-coated side (inner edge) of the composite sample

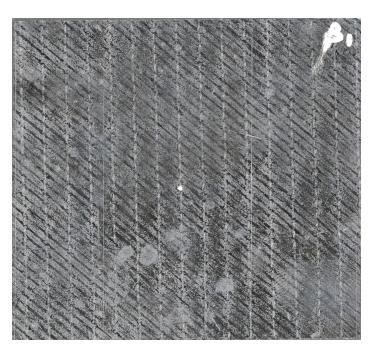
Figure 4.6: Image of gelcoated side of the composite sample

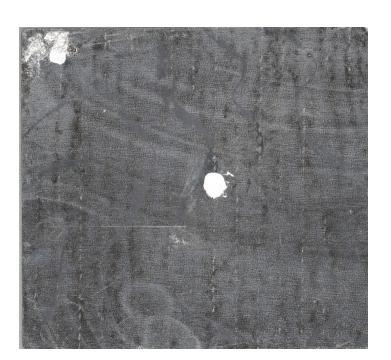
Figure 4.7: Intact gelcoat of sample A7 after 10 impacts with 15 mm SHI at 160 m/s

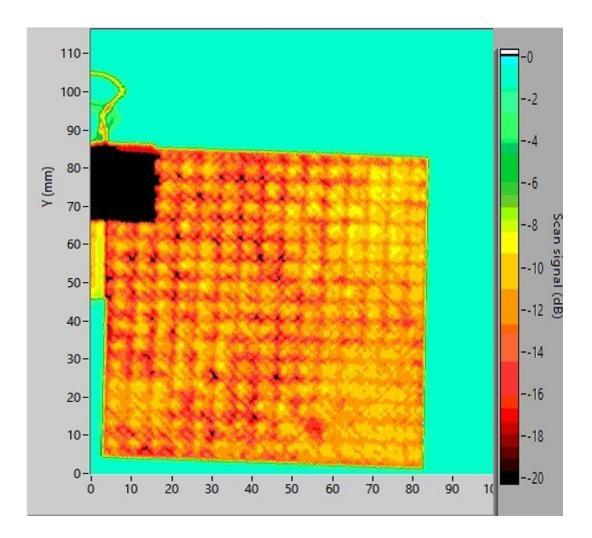
Figure 4.9: C-scan images of sample before impact with 18mm SHI at 110 m/s

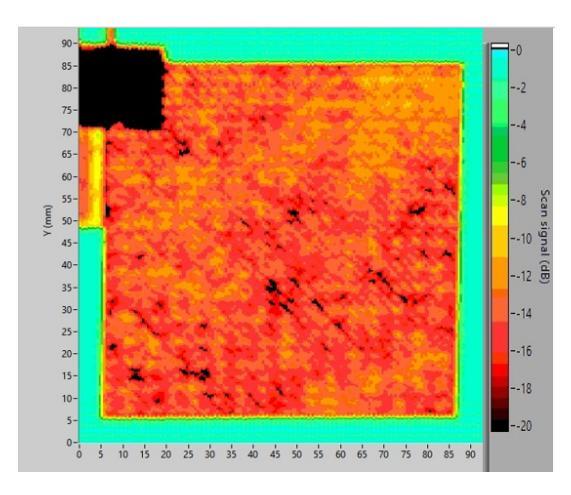
Figure 4.11: C-scan images of sample B10 before impacts with 18 mm SHI at 100 m/s

The impact damages are generally barely visible to the naked eye. Therefore, it needs to be inspected using ultrasonic testing. The C-Scan images of the sample after the impact tests are shown in Appendix:C. Sample B10 displayed presence voids(black spots), but there were no signs of apparent delamination. Comparing Figure4.11 and Figure4.12, no clear evidence suggests the voids delineated into a matrix crack because of the impacts. Overall most of the samples did not display any presence of voids or delaminations. As described in the preceding section, matrix cracks in the 45° direction were observed in specific samples when viewed from behind. Similar Observations were made by Savana [56] for composites coated with polyurethane coating.

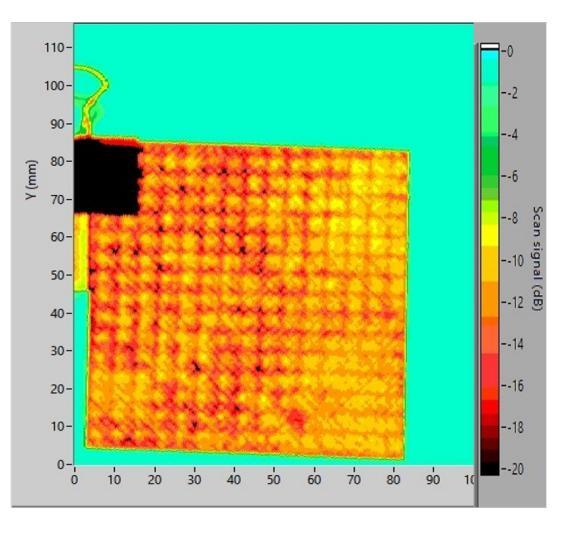
Following the impact test, the impact damages due to the SHI impact are generally barely visible to the naked eye. Therefore, it needs to be inspected using ultrasonic testing. The C-Scan images of the sample after the impact tests are shown in Appendix C. Sample impacted with 20mm SHI at 90m/s displayed presence voids(black spots), but there were no signs of apparent delamination. Comparing Figure 4.11 and Figure 4.12, no clear evidence suggests the voids delineated into a matrix crack because of the impacts. Overall most of the samples did not display any presence of voids or delaminations.

Figure 4.10: C-scan images of Sample impacted with 18mm SHI at 110 m/s(10 impacts)

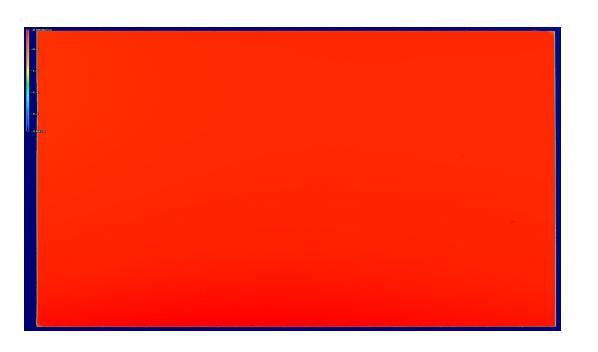
In order to analyse the coated substrate for any obvious damages post-impact, non-contact profilometry and microscopic analysis were performed. In non- contact profilometry, the surface profile was analysed, and representative images of the profile observed are displayed in Figure 4.8, Figure 4.14 and Figure 4.13. From Figure 4.15 (height map), it is evident that the sample is without any sign of coating degradation. It can be concluded from this image that the coating has good resistance for the tested parameters.

Figure 4.14: Height profile of A3 sample impacted with 18mm SHI at 140 m/s (after 10 impacts)

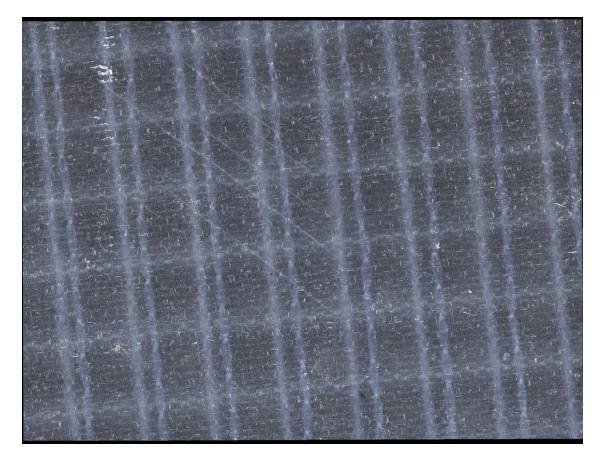
Figure 4.19: Sample A6 post 5th impact with a 18mm SHI at 140 m/s

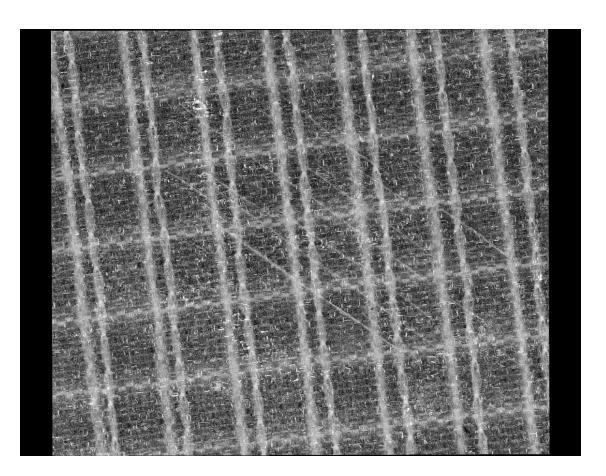
Figure 4.20: Sample A6 post 10th impact with a 18mm SHI at 140 m/s

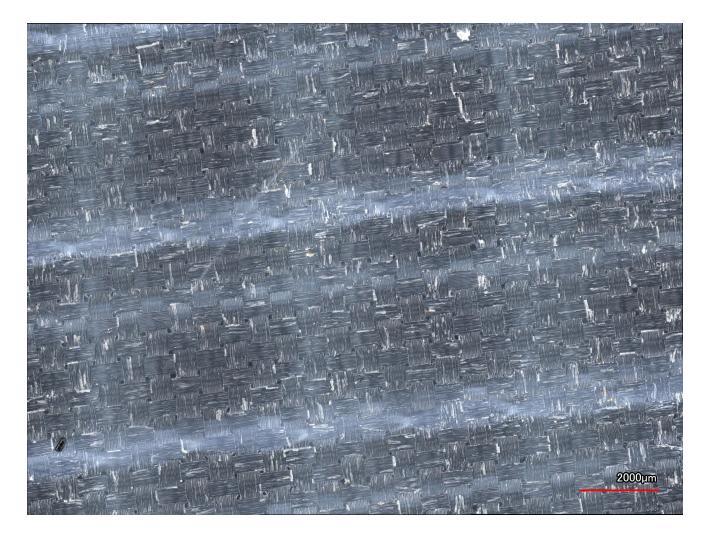
In sample B7, an interesting observation was made during impact testing 15 mm SHI at 150 m/s, the sample did not show any indication of damage after 1st impact even though kinetic energy at impact was estimated to be 18.52 J which in comparison to other impacts for the same impact parameters was above the energy level at which damage was observed. But subsequent impacts of 15mm SHI at similar velocity exhibited white striation though estimated kinetic energy was 16.64 J.

Figure B.5: Sample B7 post 5th impact

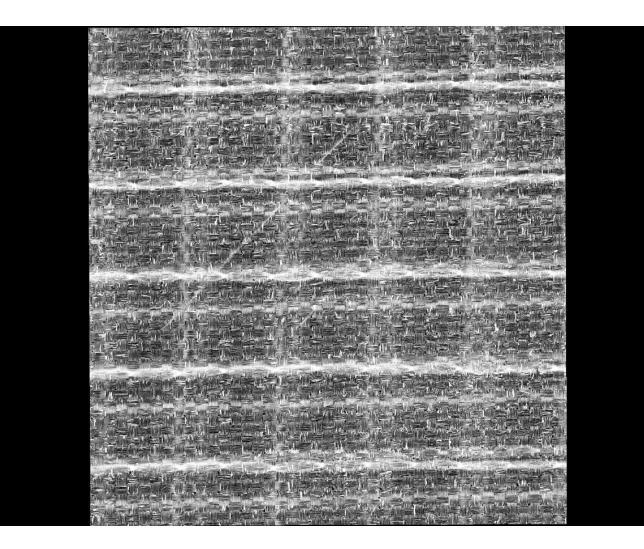
Figure B.6: Sample B7 post 10th impact
